**INVESTIGATION, RESEARCH AND TESTING****Since 1970****Vehicle Collision Reconstruction and
Biomechanical Analysis***Robert Marberger v. Jeremy R. Nivens and DZYK Transportation Services, LLC*

In the United States District Court for the
District of South Carolina, Columbia Division
C.A. No. 3:22-cv-02375-MGL

Date of Incident: September 9, 2021

S-E-A Matter No. 11.148372

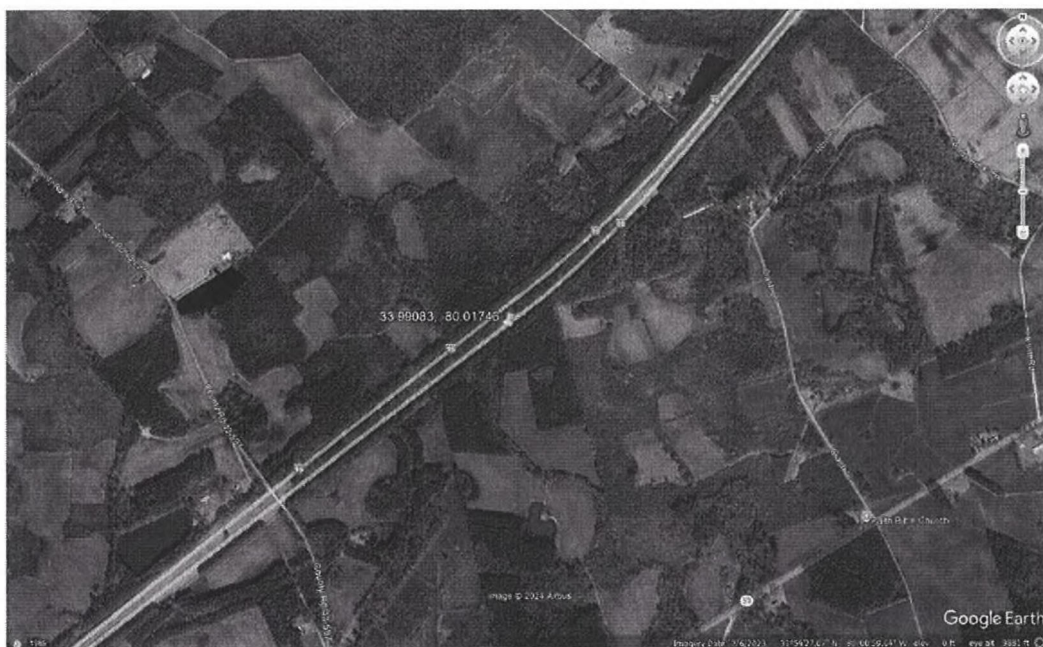
In the area of the subject MVC, I-95 generally runs northeast/southwest, with two lanes of northbound travel, a wide paved shoulder to the right and narrow paved shoulder to the left (**Figure 3** and **Figure 4**). The median is tree lined, and there is no evident guardrail or wall on either side of the roadway. According to the Crash Report, the conditions at the time were dry, clear, and daylight, with the roadway reported as straight and level.

Figure 3: Aerial image of the MVC site (from Google Earth).

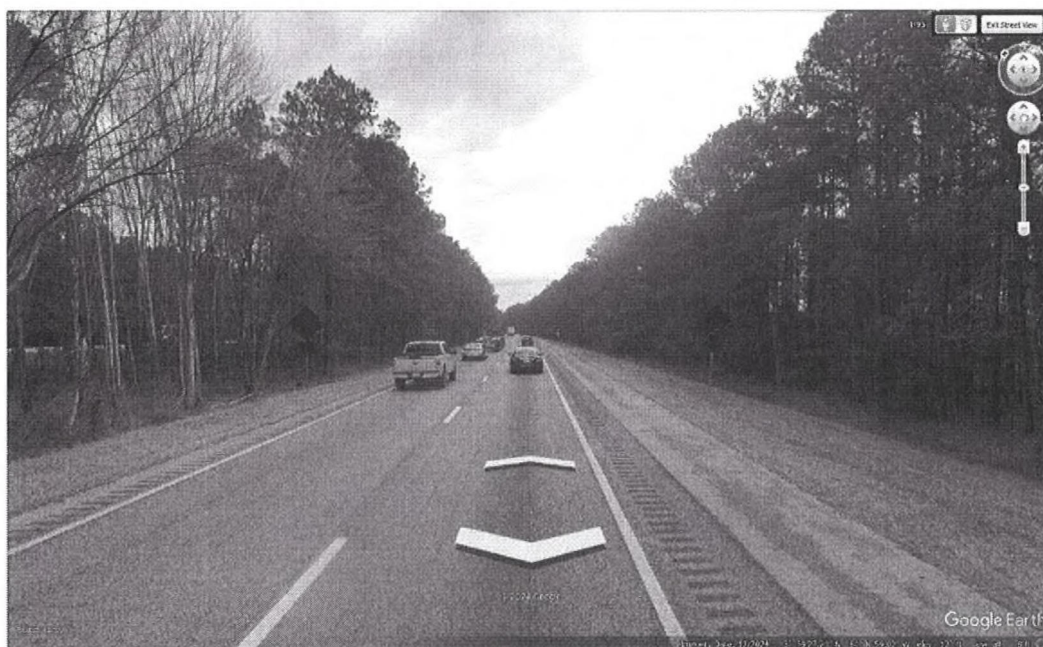
Figure 4: Street-level image near the MVC site, looking northbound (from Google Earth).
